# Research Note

## NORTHERN ROCKY MOUNTAIN FOREST AND RANGE EXPERIMENT STATION

× FOREST FIRE -- THUNDERSTORM ,

KNOCKOUT COMBINATION FOR WATERSHEDS ×

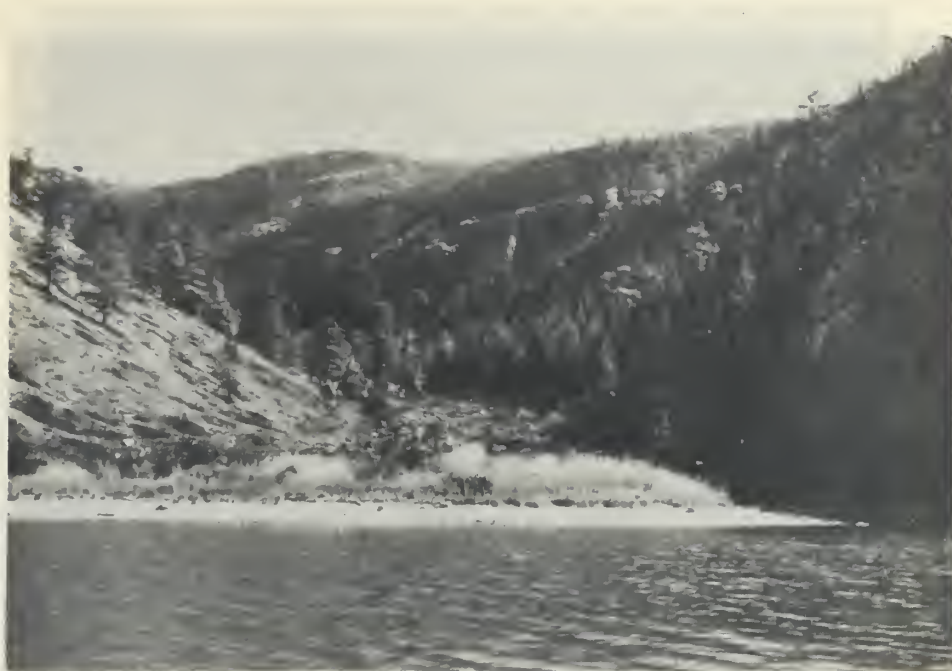
Fig. 2 - Mouth of Mann Gulch in fall of 1949 shortly after fire.  
Drainage area 950 acres.

The appearance of Mann Gulch when it was examined on August 31 was sensational, to put it mildly. Practically the entire width of the valley floor at the mouth of the canyon, about 100 feet wide, was littered with rocks, trees and other debris deposited by the August 11 flood (figs. 2 and 3).

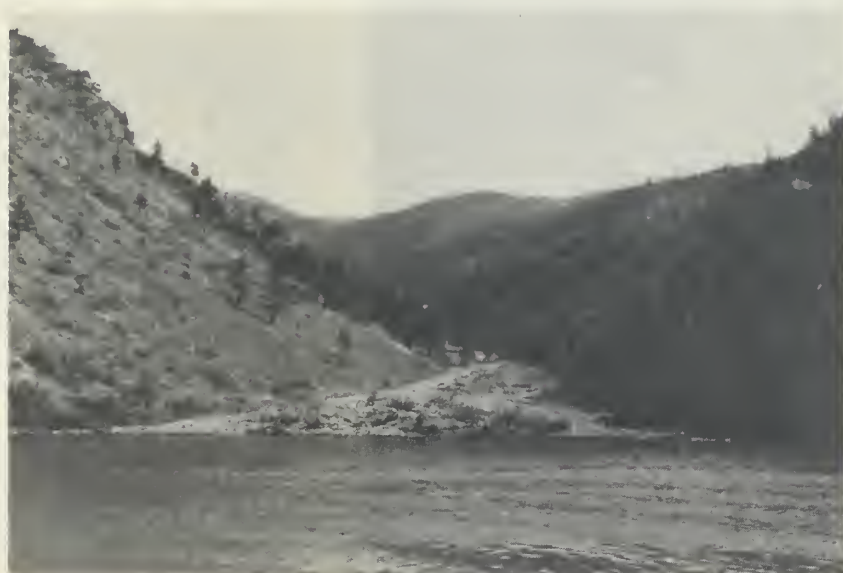
Fig. 3 - Mouth of Mann Gulch as it appeared on August 31, 1950,  
following the thunderstorm of August 11. Note heavy  
deposit of recent debris.

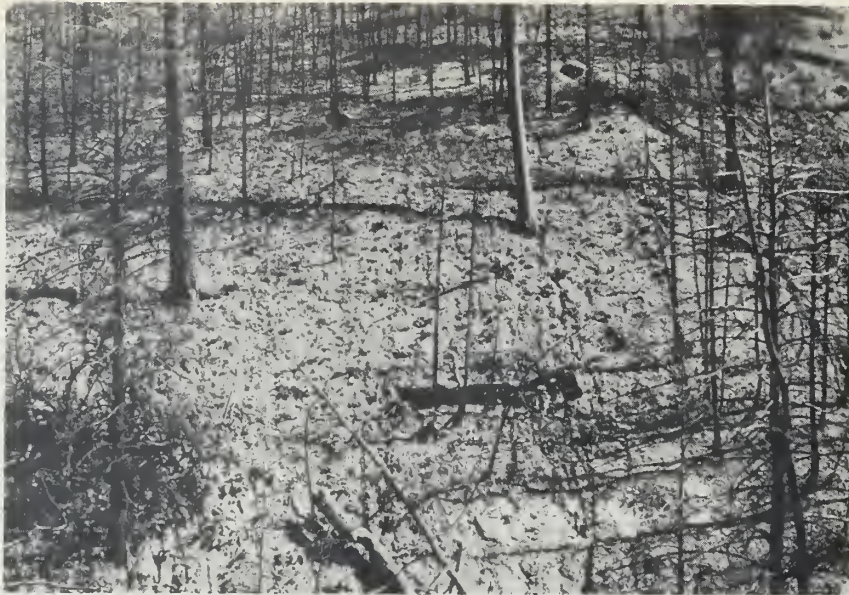
Fig. 4 - Type of erosion that occurred very commonly on the steep, formerly timbered slopes of Mann Gulch.

Erosion on the north-facing, burned-over forest land varied from relatively mild, as described above (fig. 4), to very severe, with numerous gullies nearly a foot wide and a foot deep (fig. 5). Wherever the runoff accumulated into side draws on the south side of Mann Gulch, the old alluvial fans were covered by fresh deposits of rocks and debris and in some cases new gullies were cut (fig. 6).

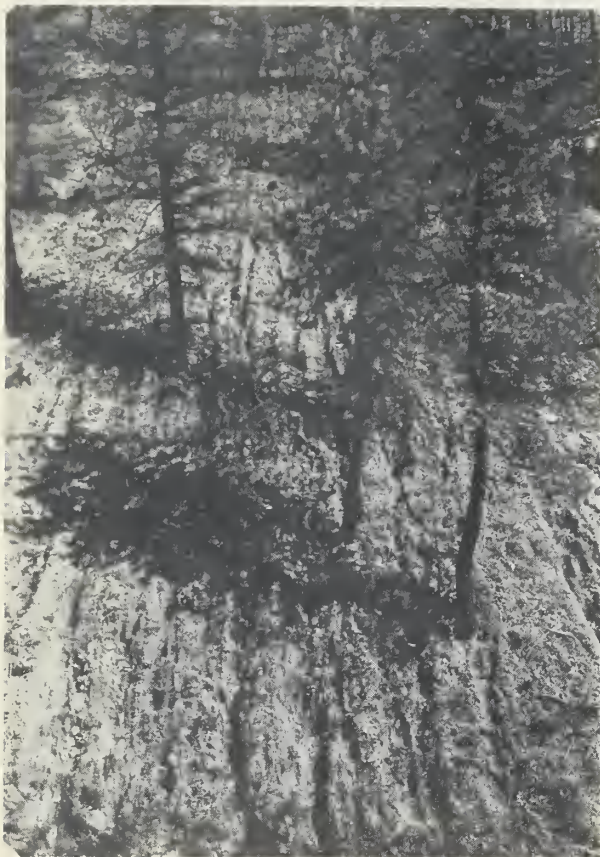
Fig. 5 - An example of very severe erosion on the formerly timbered slopes of Mann Gulch. Though less common than the type shown in fig. 4, there was much of this erosion class.

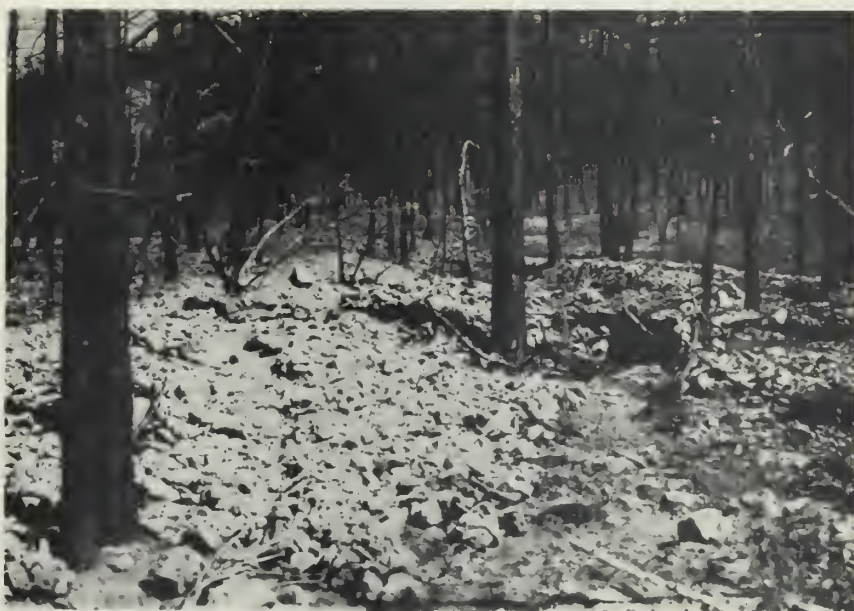
Fig. 6 - Rock deposits and a new gully on the alluvial fan of a draw coming into Mann Gulch from the south, about  $3/4$  mile from the river. Drainage area about 100 acres.

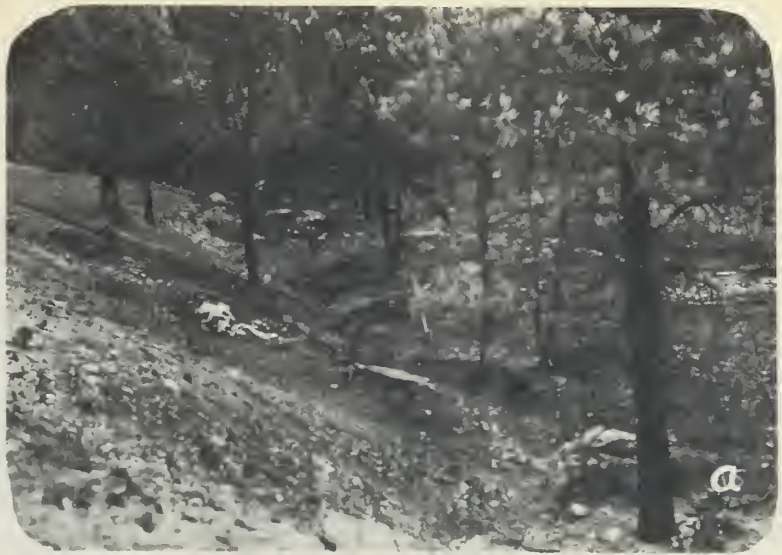
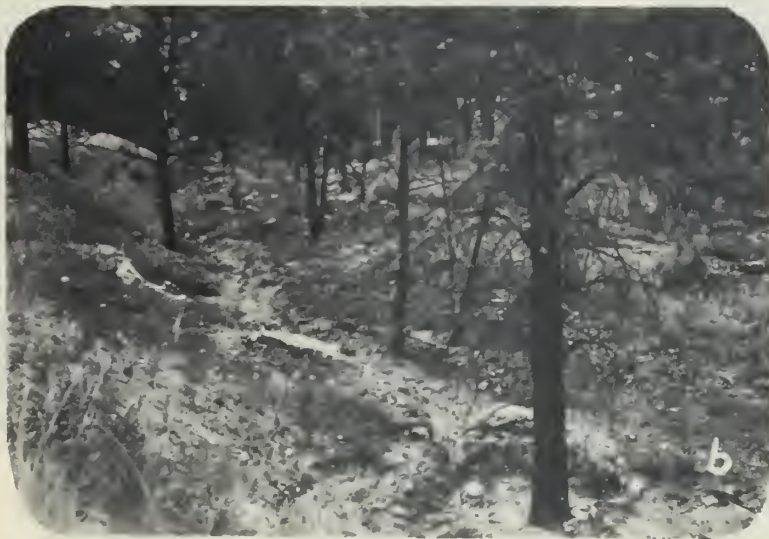
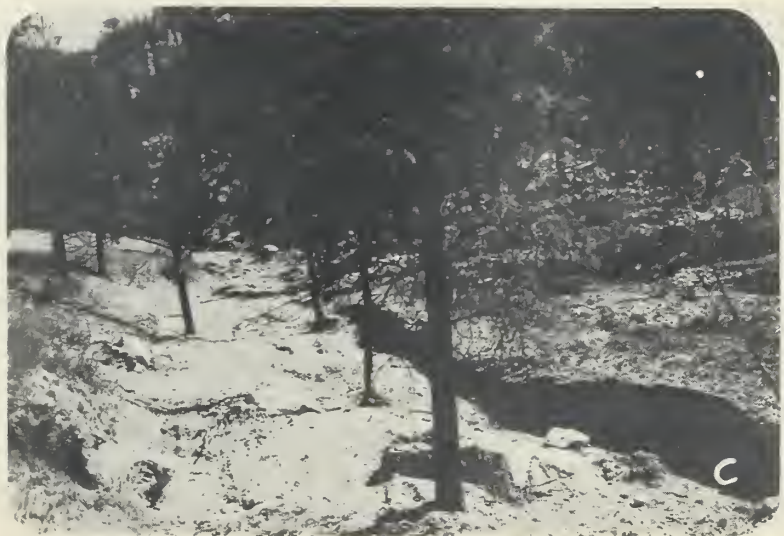
Fig. 7 - Main channel of Mann Gulch at Transect "A" about 1/4 mile above its mouth. (a) In October 1949 soon after fire; (b) July 14, 1950 shows marks of runoff from spring snow melt; and (c) August 31, 1950 after storm of August 11, 1950. Drainage area about 900 acres.

Remeasurements made by personnel of the Northern Rocky Mountain Forest and Range Experiment Station in July 1950 of three erosion transects (A, B, and C in fig. 1) established in the fall of 1949 revealed that up to that time runoff and erosion from spring snow melt and other precipitation since the fire had been negligible, (figs. 7a, 7b, 9a, 9b).

The erosion transects in Mann Gulch were remeasured and rephotographed on August 31. Transect "A" (fig. 7) crosses the main channel of Mann Gulch about one-fourth mile from the river. Transect "B" (fig. 8) is on a short, timbered side draw entering Mann Gulch from the southeast about a mile above the river. Transect "C" (fig. 9) is on the main channel just below transect "B".

The before and after views (figs. 7, 8 and 9) of the transect locations show what happened all along the main channel. At transect "A", for example, the original cross sectional area of 52 sq. ft. was enlarged by 17 sq. ft. of cutting and reduced by 1 sq. ft. of fill. Transect "B" had an original cross section of 21 sq. ft. and was enlarged by 15 sq. ft. or about 67 percent, and transect "C" with an original cross section of 49 sq. ft. was cut out by 12 sq. ft. and received 6 sq. ft. of fill.

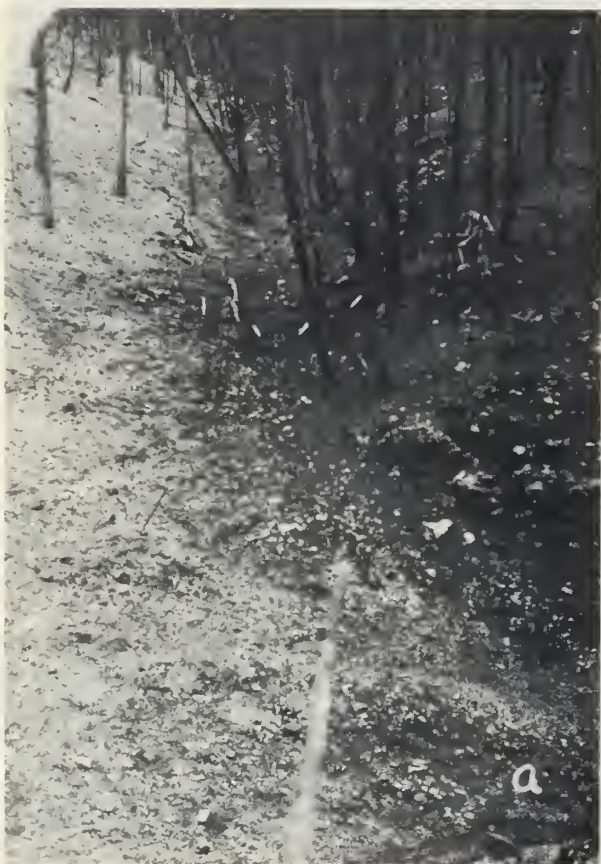
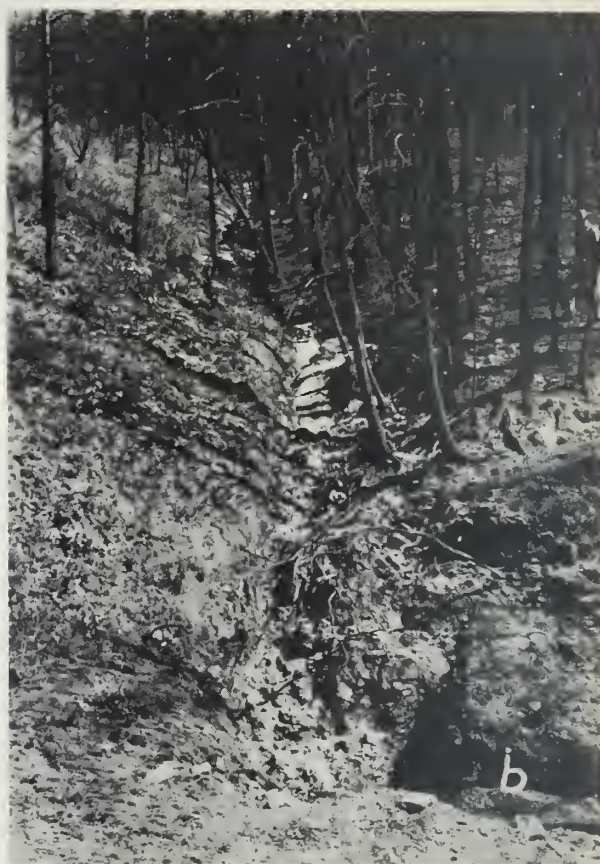
Fig. 8 - Two views of channel of the small side draw where Transect "B" is located showing conditions in October 1949 (a), and on August 31, 1950, following the storm of August 11, 1950 (b). Drainage area about 50 acres.

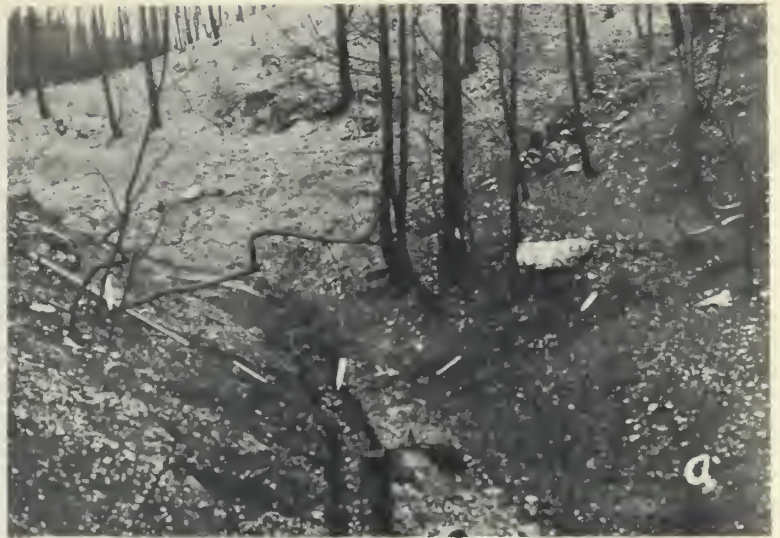
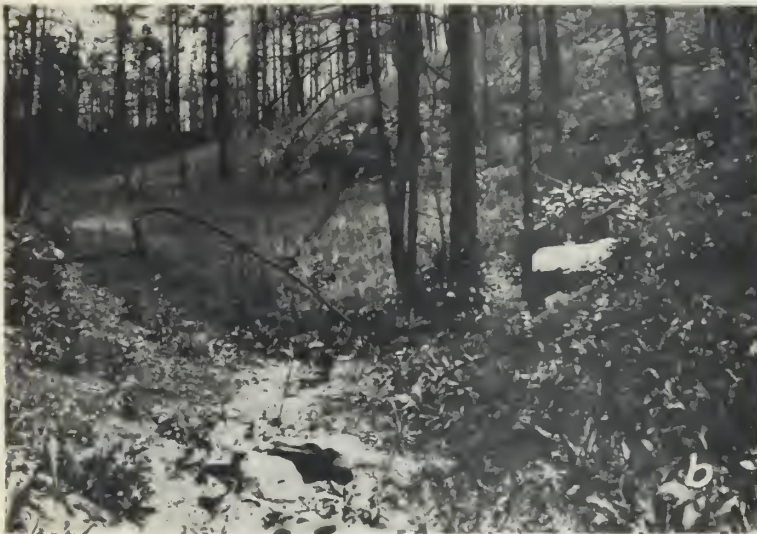
Fig. 9 - Three views of main channel of Mann Gulch at Transect "C". (a) In October 1949; (b) July 14, 1950; and (c) August 31, 1950. Drainage area about 500 acres.

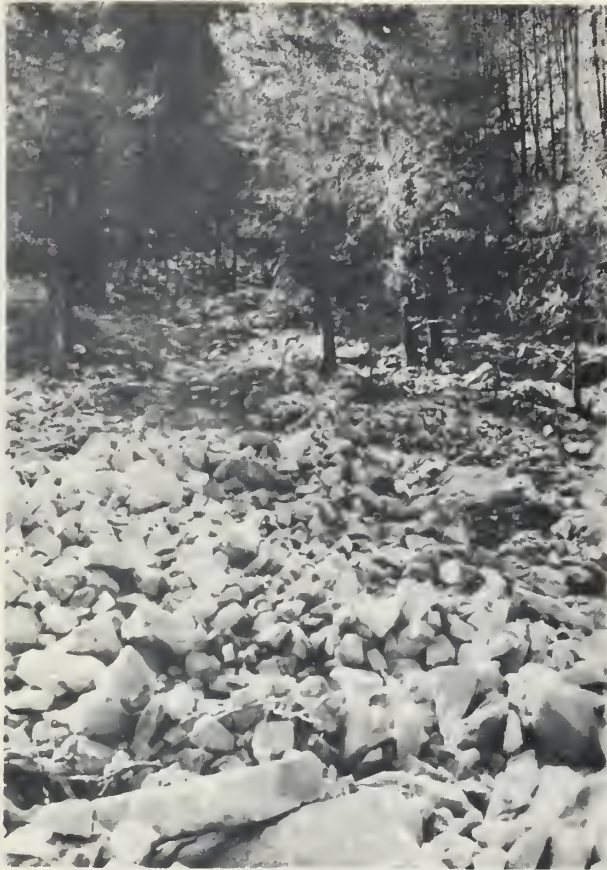
Fig. 10 - Portion of a mud and rock flow which emerged from a burned-out side canyon on August 4, 1950, blocking the Willow Creek road. Drainage area about 150 acres.

In one place about a mile below the Ives ranch, a mud and rock flow came out of a short, steep side drainage from the south depositing rocks and debris 2 to 3 feet deep along some 30 yards of the road (fig. 10).

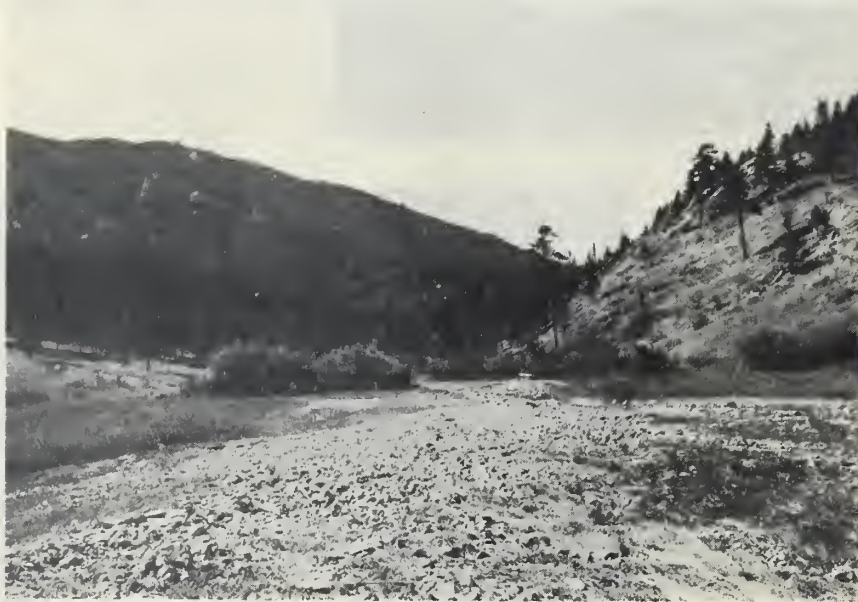
Fig. 11 - Rocks and gravel in mouth of draw entering Willow Creek above Ives ranch. Flood waters came from burned-over mountains in background.

About one-half mile above the Ives ranch, a drainage of about 500 acres and 2 miles in length heads just west of Willow Mountain and enters Willow Creek from the south. There had been a big flow from this canyon which deposited rocks and gravel over two acres of an alfalfa field between the canyon mouth and Willow Creek (fig. 11). Inspection of the main channel a short way above its juncture with this side drainage showed that practically no runoff occurred from the upper half of Willow Creek drainage - some 10 or 11 square miles which had not been burned - while a very severe flood occurred in the lower half, most of which burned over in 1949.

There were patches of timber here and there in the vicinity of the Ives ranch that were not damaged by the fire (foreground, fig. 11). In these places it was impossible to recognize any signs of recent erosion, or even that a heavy rain had occurred. In figure 14 is shown a small unburned drainage a few chains west of the one in figures 11 and 13. It is noteworthy that obviously no water has entered this meadow from the forested area of about 50 acres. There is no question but that there would have been some very evident signs of erosion here, too, if soil surface conditions similar to those shown in figures 4 and 11 had existed in this small drainage.

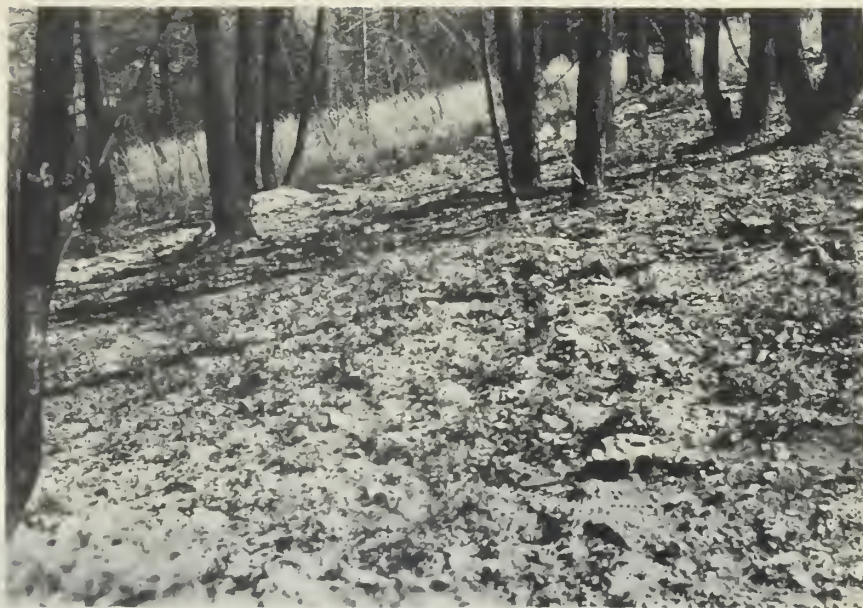
Fig. 12 - Nearly bare ground surface on a gentle slope near the base of Willow Mountain showing sheet erosion typical of the gentler terrain within the burned area.

Several degrees of erosion were observed on the burned-over forest land in Willow Creek. Sheet erosion occurred wherever the ground was left bare (fig. 12), shoe-string gullies occurred on bare ground wherever slopes were long enough for water to concentrate, and big gullies were cut in the bottoms of the draws (fig. 13).

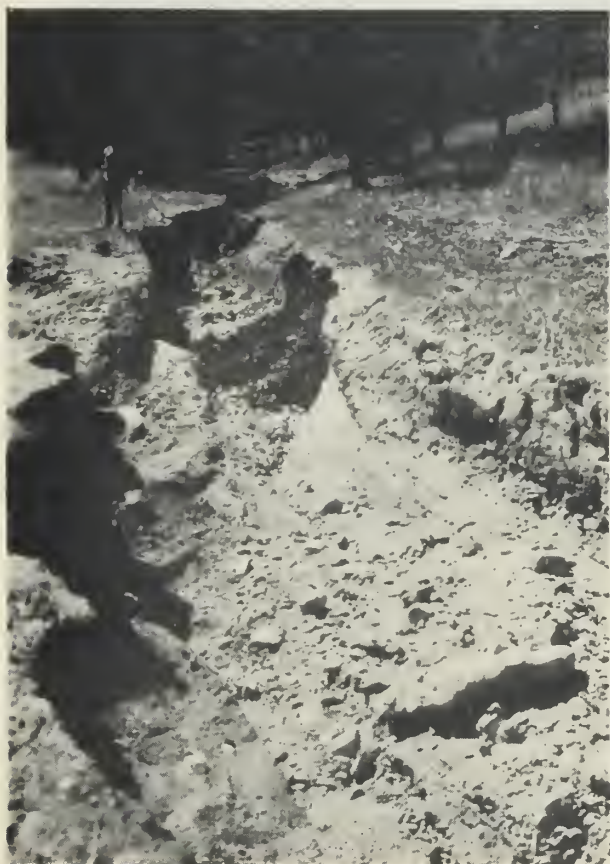
Fig. 13 - A new gully formed in the bottom of the draw shown in fig. 11. This must have been the source of much of the debris dumped on the meadow below.

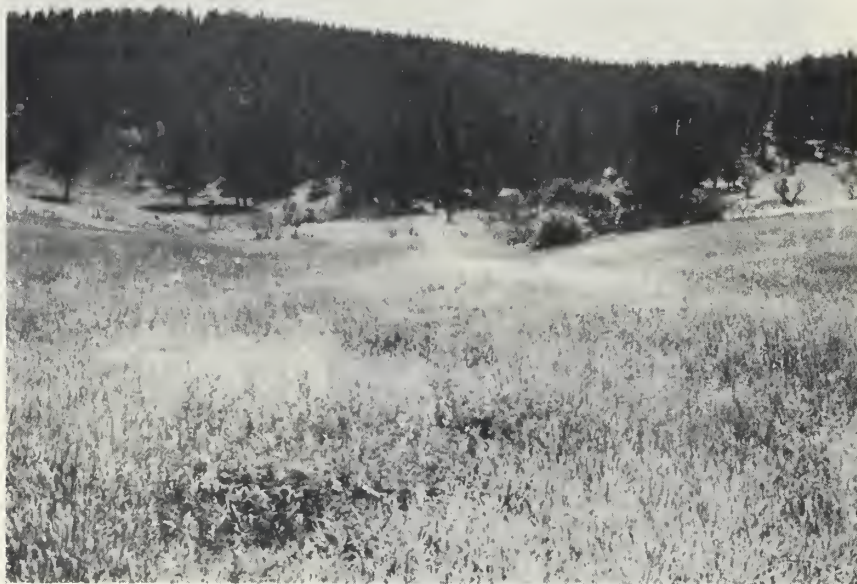
Fig. 14 - View of a side draw of about 50 acres which did not burn and from which apparently no surface runoff occurred. The view was taken looking directly up the channel in which the water would have flowed. It is only a few hundred feet from fig. 11.
